25455/25460/25465/25470/25480/25485/25490

Toyota Adjustable Upper Control Arms

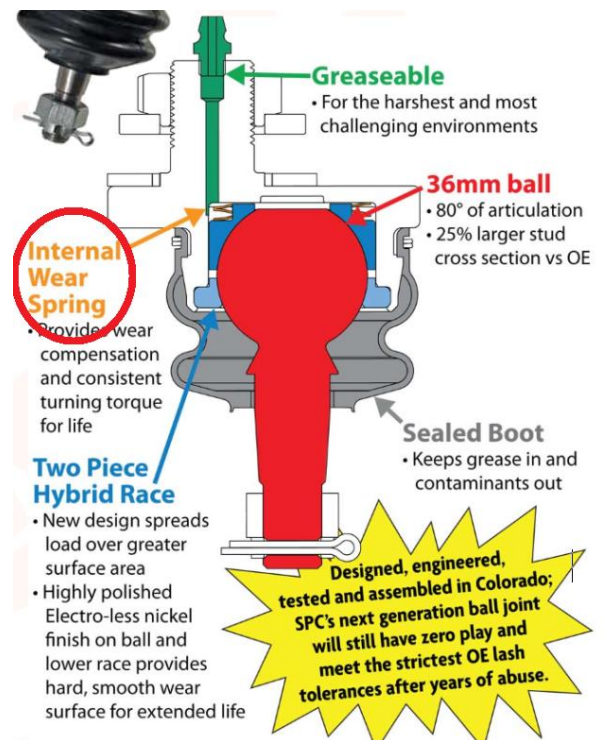
A12: Our grease-able ball joints incorporate an internal spring that keeps a constant pressure on the ball stud. Proper inspection should look for radial play only. Any vertical wear is compensated for with a wear spring.

Pull knuckle extension straight out and zero dial indicator. Push knuckle extension straight in and record movement. See **green** arrow of Fig. 3. There should be no perceptible radial motion.

NOTE: Checking for axial / vertical play (up/down) is not necessary, because the spring can be compressed if excessive force is used. Compression of the spring is NOT wear! If a shop insists on checking it this way, they should use a dial indicator to measure axial movement. If more than 0.050" of movement is present, then the ball joint should be replaced. This is represented by the **red** arrow of Fig. 3.
