**TECHNICAL BULLETIN-0006**  
**DODGE AND JEEP PIN JOINTS**  
**DESIGN AND DIAGNOSIS**

**Specialty  
Products  
Company**

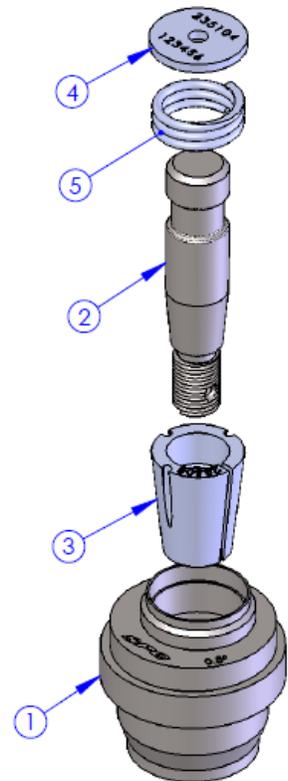
For many years Dodge and Jeep have been using a solid axle in the front of their four-wheel drive SUV's and trucks. Dana 30, Dana 44 and AAM925 are the most common. These vehicles have two 'ball' joints per side, but the truth is that they really only have one actual ball style joint per side and that is the lower joint. The upper ball joint is actually a pin design not a ball design. The pin in the upper joint is held in place by spring loaded bushings (3) that hold the pin (2) in place so it can pivot. The pin itself is designed to move up and down in the bushing and housing about ½ inch or 12mm.

This design relaxes the axle housing tolerances so the joints can pivot with a minimal amount of tension between the two. This system has worked very well for many years, but it is easy to mis-diagnose ball joint play if you are not aware of how the system works.

A common way to check for ball joint play is to raise the vehicle by the axle and then check for axial movement with a pry bar under the tire. Then check for radial movement by pushing the tire in and out. If there is up and down movement in the first test this would indicate play in the lower ball joint, but it is not an indication there is a problem with the upper joint. Again, the pin in the upper joint can move up and down. Check the ball joint specifications for your specific vehicle to see if any axial or radial play is allowed by the manufacturer. If no play is allowed the lower joint should be replaced. Any side-to-side play in either joint is normally not acceptable and would indicate replacement of either or both joints but again check the specifications.

I know there is a lot of labor involved in replacing these joints so why not just replace them both at the same time? If both joints are OE and have not been replaced, I would be inclined to replace them both if indicated by testing. But if the upper pin joint has been replaced recently to correct an alignment issue, then the lower joint may be the only one needing service.
