## Specialty Products A

## Part Numbers 93080/93090

## Mustang II Dropped Spindles

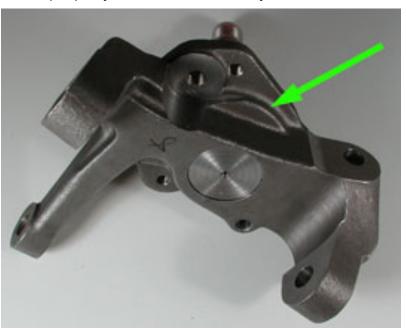
Q1: The caliper bracket will not fit properly on the new spindle. What can be done?

A1: Some caliper brackets may not fit properly because of a casting protrusion on the back of the spindle housing. This can easily be remedied by grinding of enough of the castings so the brake caliper bracket will fit properly. Fit your caliper bracket and grind off just enough to make mounting bolt holes line up properly. Do not remove any more material than necessary.
