CHRYSLER REAR CAMBER BUSHINGS (PAIR)

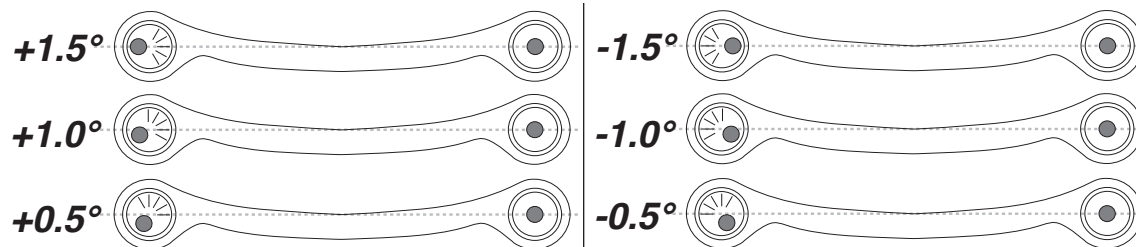
Figure 1 Camber Change - Both bushings (for the forward and rear upper arms) must be indexed for the same change as shown.
(Note: Index only in the direction indicated - bolt hole towards bottom part of arm)

Note: Desired Camber change will be achieved by 'clocking' the SPC bushings to appropriate index mark as shown in **Figure 1**. To avoid binding and setback changes the SPC bushings in BOTH the forward and the rearward upper arms must be oriented for the same amount of positive or negative change.

On the older models with aluminum arms this will mean the bushing is 'offset' from the arm (**Figure 3**). Press in the bushing from the side that will result in the arm being located away from the knuckle when mounted. Also for lesser change (0.5° or 1.0°), the hole in the bushing should be biased down (**Figure 1**).

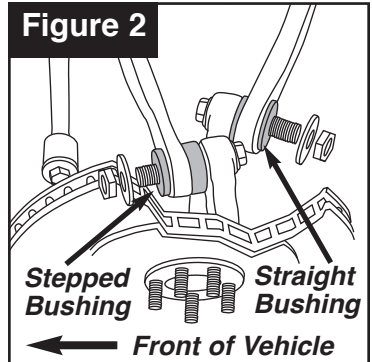
5. Properly index and press the bushings using #40910 bushing press and #66025 press adapter kit into both arms. The forward (shorter) arm uses the stepped bushing which must be installed as shown below (**Figure 2**). Press the appropriate 'half' of the bushing that matches the original diameter into the arm.

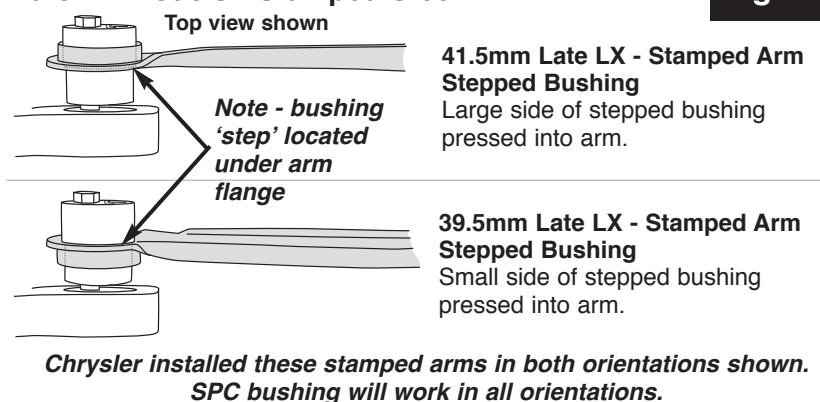
Figure 4

On the newer models with stamped steel arms the bushing must be seated so that the step in the bushing is located under the arm flange (**Figure 4**).

Late LX Models - Stamped Steel Arm
